# Hazard Mitigation Loss Avoidance Study Russell County, Virginia

Town of Cleveland Acquisition(s)  
2014 Pre-Disaster Mitigation

**March 2022**

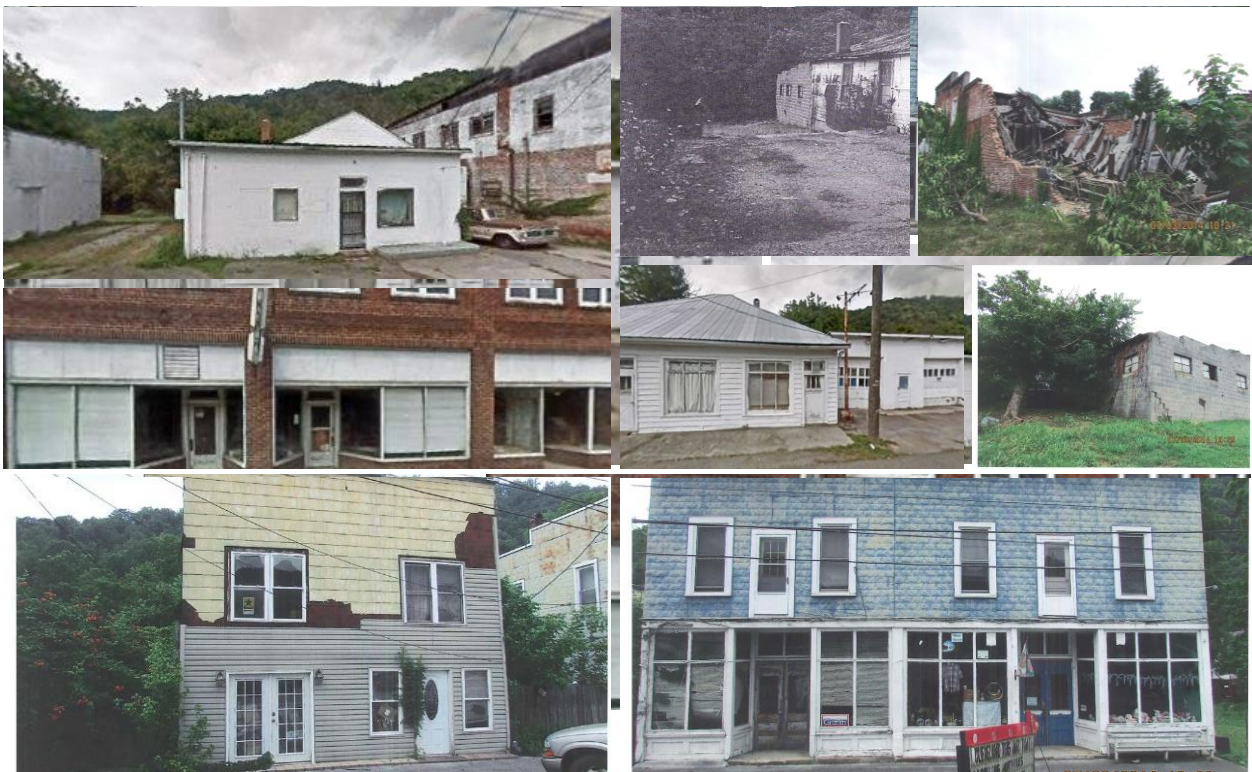
*Figure 2: Mitigated Properties*

The Town of Cleveland is located in the southwest central portion of Russell County along State Route 82, approximately seven miles northwest of the County seat (Lebanon). The mitigated properties were located along the Clinch River which runs through the Town of Cleveland. The buildings were blighted and collapsing (Figure 2). The property owners were contacted and agreed to the demolition.

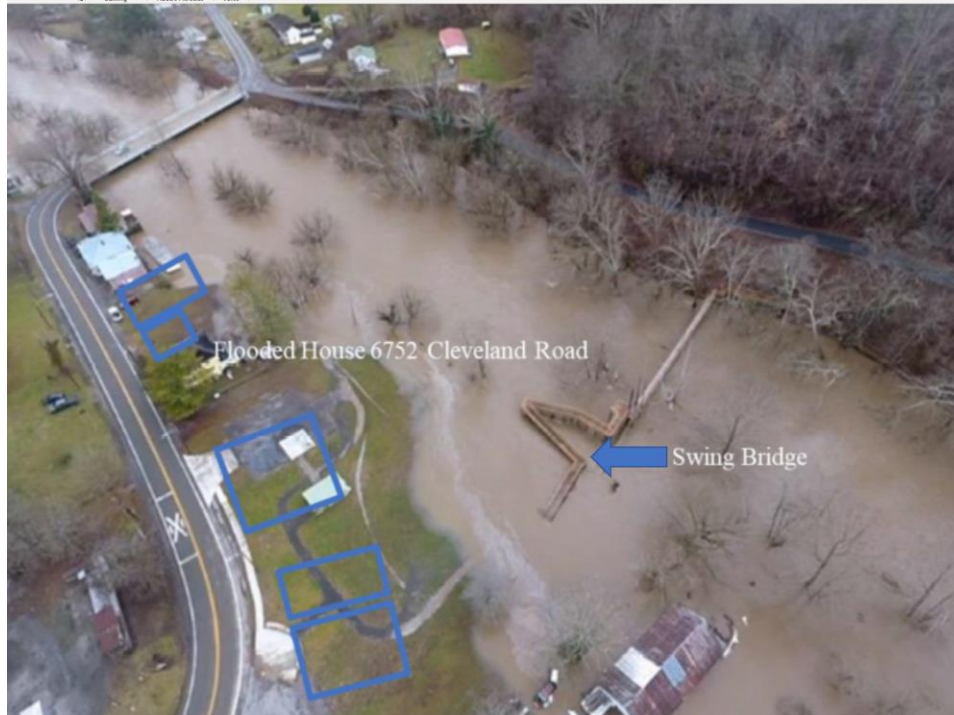
*Figure 5: Image of mitigated property parcels flooded in February 2020 rain/flood event*

The flooding event that occurred post-mitigation being studied is a February 2020 rain event. On February 4, 2020, the National Weather Service (NWS) issued a Flash Flood Watch for southwest Virginia for a strong storm system moving through the area producing heavy rain with 2 to 4 inches of rainfall. On February 6, the Emergency Management Assistant Director for Russell County declared a local emergency due to a record amount of rainfall and flash flooding, rock/mud slides, and high water on roadways. It was estimated that \$244,124 of damage occurred to private property, and \$348,825 to public property totaling \$592,949 in damages. Figure 5 depicts area flood conditions. A remaining structure in an adjacent parcel to the mitigated properties sustained \$4,850.00 in damages. Figure 5 depicts receding flood waters at the location of the mitigated properties.

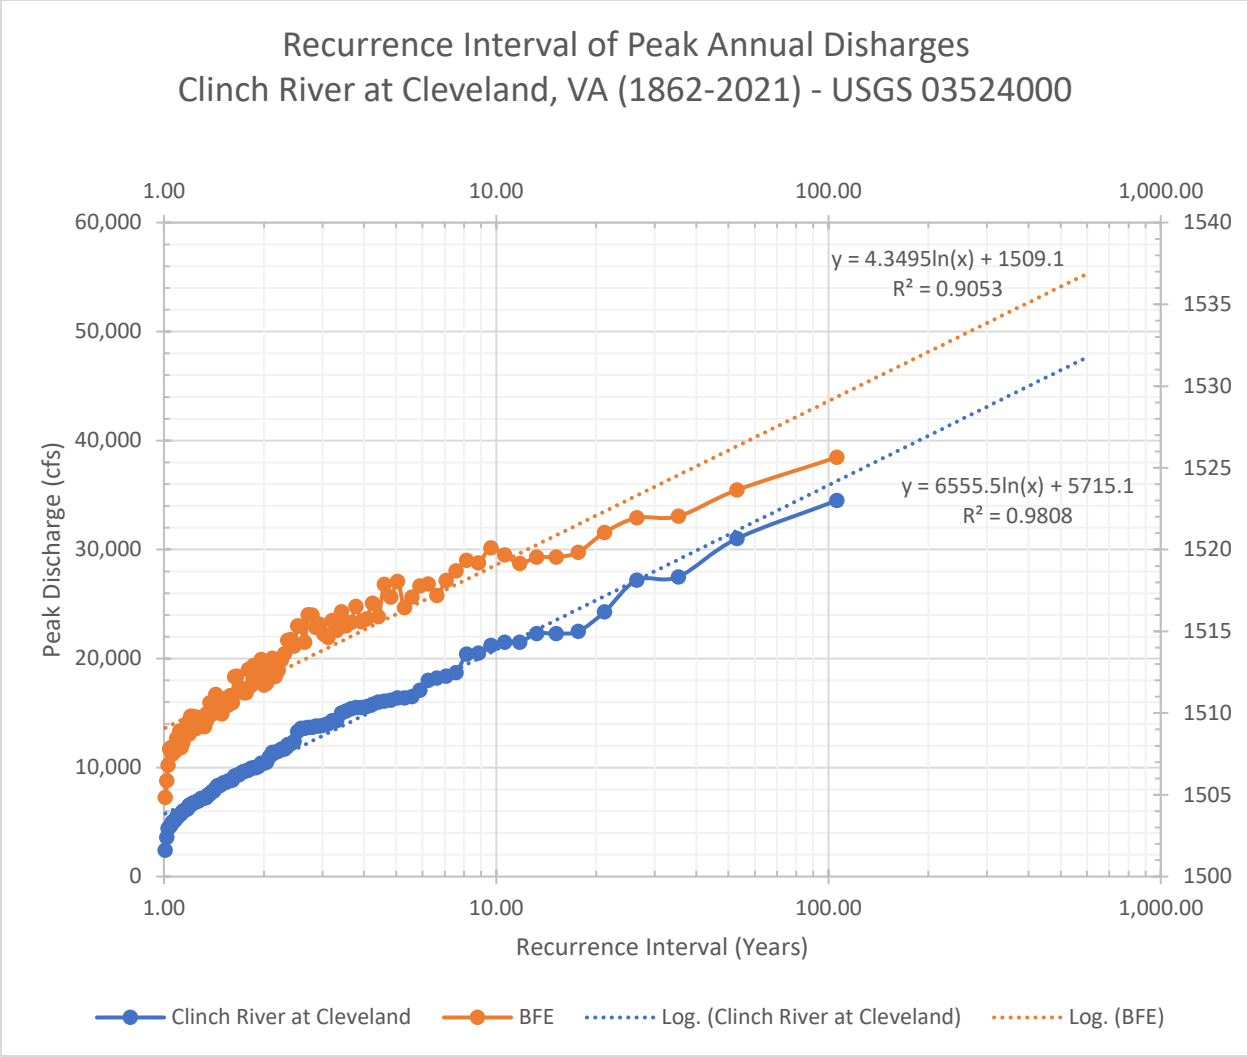
*Figure 6: Stream discharge and flood depth elevation*

*Table 4: Recurrence interval stream discharge and flood depth elevation*

Recurrence Interval	Stream Flow (cfs)	BFE
10	20,810	1,519.12
50	31,360	1,526.12
100	35,904	1,529.13
500	46,455	1,536.13
